Intel[®] Pentium[®] III Xeon[™] Processor Specification Update

Release Date: April 2005

Order Number: 244460-040

The Pentium[®] III Xeon[™] processor may contain design defects or errors known as errata that may cause the product to deviate from published specifications. Current characterized errata are documented in this Specification Update.

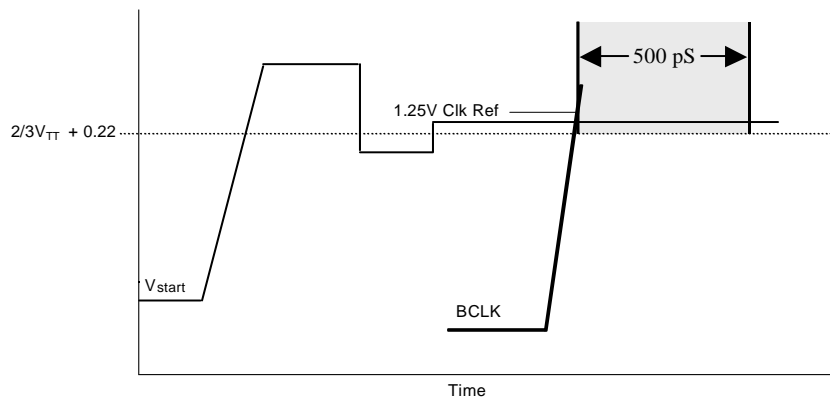
Intel has characterized the new AGTL+ AC specification for $V_{IH(MIN)}$ on the processor's RS0# signal to be: $(2/3 \cdot V_{TT}) + 0.22$ Volts within 500 picoseconds following the rising edge of BCLK crossing the 1.25-Volt threshold. See below.

Implication: The deviation from the published specification results in decreased noise margin on the RS0# processor input. This decreased noise margin has been observed to be particularly detrimental in system environments where the RS0# processor input is being driven by an I/O buffer with a pull-up device (such as a p-channel transistor) that is switched off mid-cycle. Systems that employ I/O buffers that keep the pull-up device on for the entire cycle are significantly less affected by this erratum. The reduction in noise margin may lead to the generation of BINIT# (when enabled) resulting in a system reset, otherwise this condition may lead to a system "hang" condition.

Workaround: If a system design cannot meet the specification deviation, the following areas should be carefully examined to assure that additional margin exists in order to compensate for any deficit observed with respect to the newly characterized $V_{IH(MIN)}$ specification:

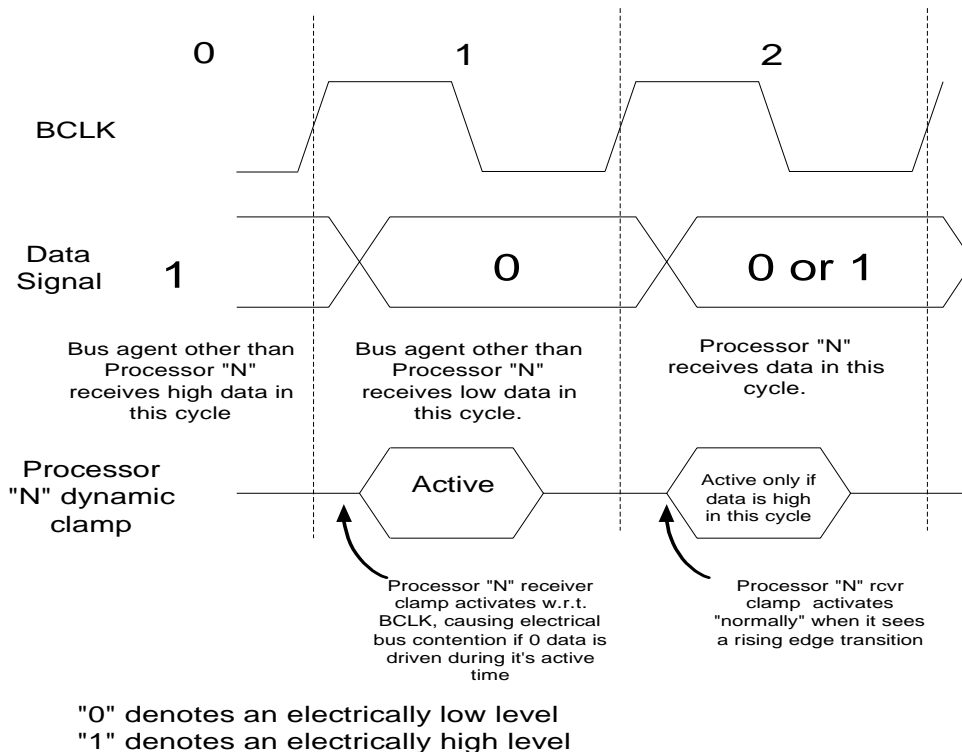
Problem: Falling edge ledge push-out and undershoot may be seen on AGTL+ data and data bus ECC signals. The AGTL+ receiver's dynamic clamp circuit activates (i.e. clamps the signal to an electrically high level) in certain cycles when data is driven to an electrically low level by another agent.

Implication: This erratum only occurs on a processor that does not receive data in that particular cycle. More specifically, this erratum only occurs when a specific processor does not receive data in the current BCLK period, but receives data in the very next period. Therefore, the processor inducing this falling edge noise (on data and data bus ECC signals) will not actually read the data in that cycle. See below for an illustration of this erratum affecting a processor denoted Processor "N". The falling edge ledges and undershoots may affect the signal quality and/or timing at agents that receive data in that cycle. Therefore, the impact of this erratum is highly dependent on system bus design.

Workaround: Evaluate system bus signal quality and timing margin at the valid receiving agent as a result of this falling edge noise. Due to dependence upon system bus design, bus layout may be evaluated to determine the need for improvements in signal quality and timing margin at the valid receiving agent as a result of this receiver-induced falling edge noise.
